Route 3 Safety Improvements Study

Peabody Drive, Mount Desert

September 9, 2020

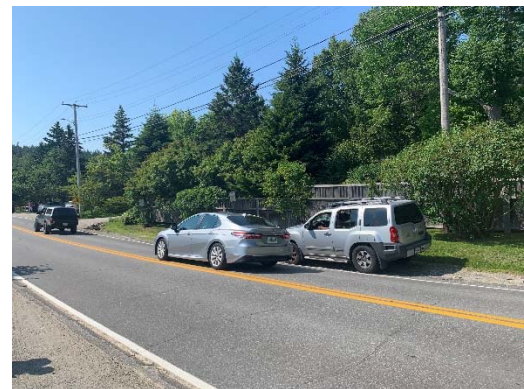
Cars pulling off road just east of Little Long Pond parking area

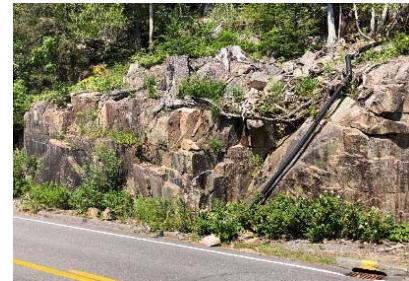
Rock wall and waterline – taken from guardrail looking north

- Roadway instability and degradation – the retaining wall failure on the shore side is causing the roadway to slope down towards the water and both sides of the roadway edges are deteriorating.

- Compromised guardrail – due to the retaining wall failure and roadway instability, the guardrail has also been compromised. However, improvements were made since the time of the field review and the guardrail has been replaced along this segment.

- There are several options for addressing the roadway instability due to retaining wall failure on the shore side of Peabody Drive:
 - Continue to fill in with pavement, as has been done in the past. This is a temporary measure and more permanent countermeasures should be planned to proactively address the roadway instability, which would reduce the chances of having to conduct costly emergency repairs.

- Replace retaining wall and provide wider shoulders on both sides of the road, which would provide numerous benefits, including providing recovery space, providing a wide shoulder for bicyclists and pedestrians, and general roadway longevity.

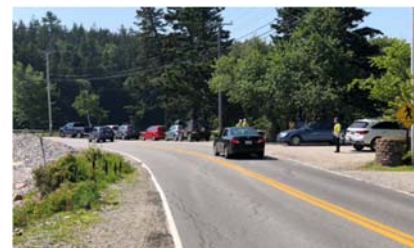
Little Long Pond is a popular destination and during the peak season, the parking area is oftentimes full.

- Parking conflicts – while having designated parking helped to increase expectancy for drivers along the corridor, the RSA Team noted several issues with the parking area. The parking was located at the bottom of a vertical curve and was in the middle of a stretch of road with many horizontal curves. Therefore, drivers could not see the parking area ahead of time, with some cars backing into the roadway. There is limited enforcement of no-parking areas.

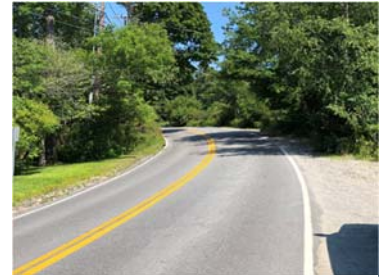
Eastbound view from the shore-side of the site displaying the horizontal and vertical curvature approaching the site.

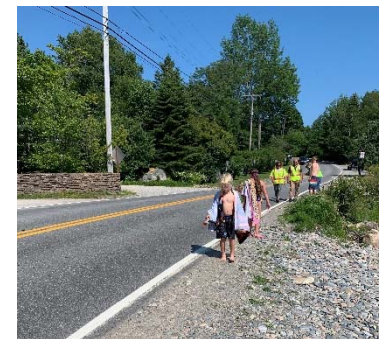
Pedestrians walking from their parked vehicle to the shore at Little Long Pond.

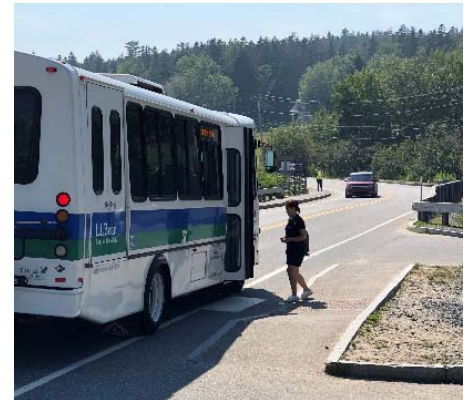
The transit bus oftentimes stopped on the crosswalk to pick up waiting passengers at Seal Harbor.
